USA/VRADCOM-TM-80-D-7

INVESTIGATION OF HELICOPTER WIRE STRIKE
PROTECTION CONCEPTS

LeRoy T. Burrows

June 1980

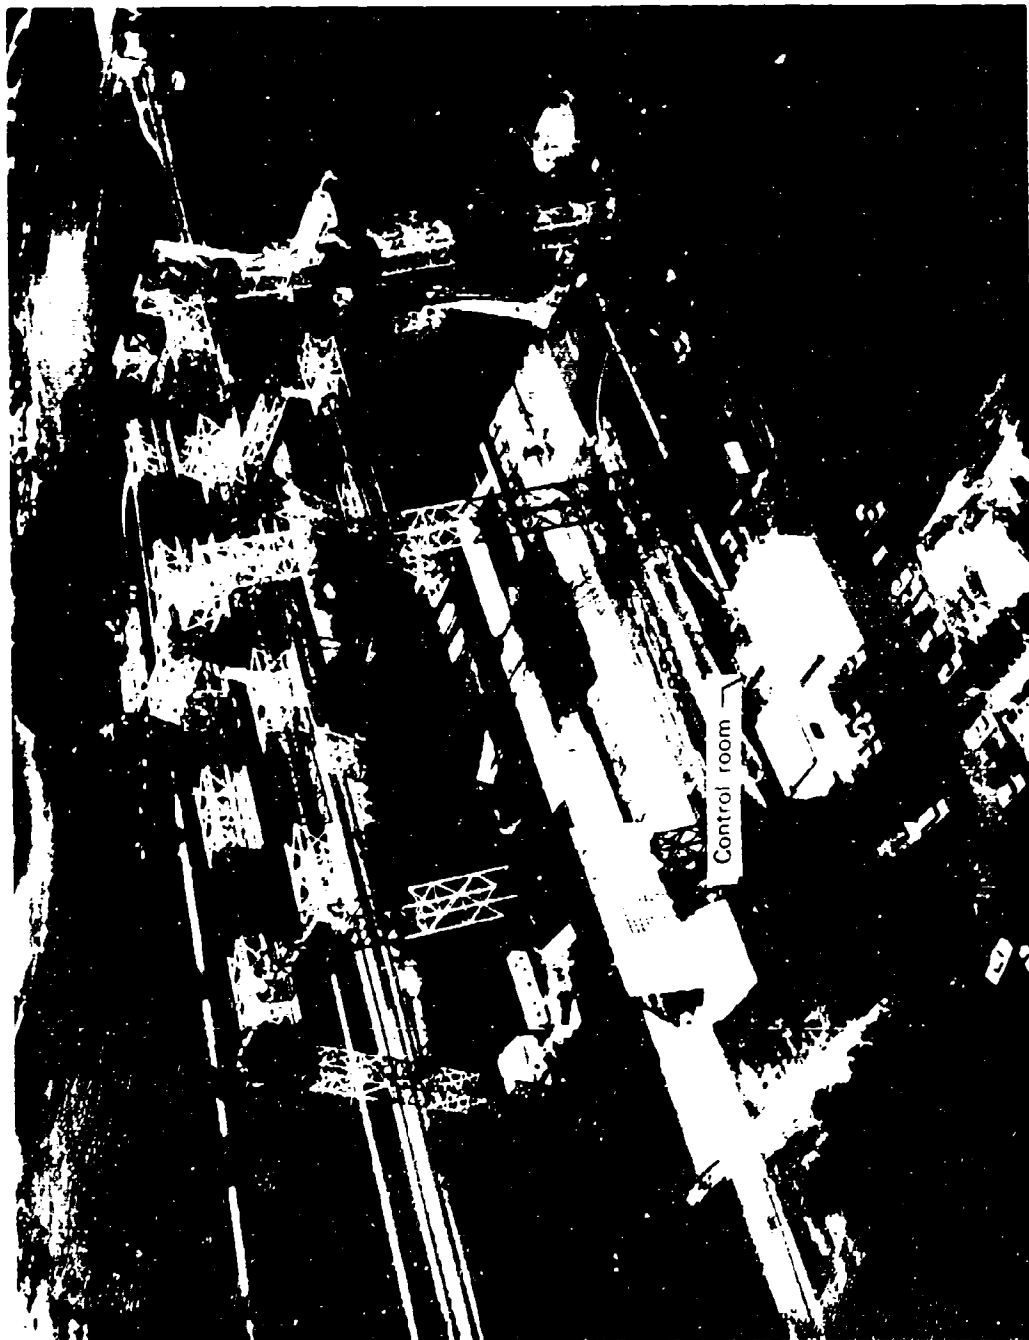
Figure 1. Langley Crash Impact Dynamics Research Facility.

The OH-58A Wire Strike Protection System test was performed at the Crash Impact Dynamics Research Facility shown in Figure 1. The basic structure of the facility is the 420-foot-high by 400 foot-long gantry. It is supported by three sets of inclined legs spread 267 feet apart at the ground level and 67 feet apart at the 218-foot level. A movable bridge spans the gantry at the 218-foot level and traverses the length of the gantry. A control room and an observation room are located in the building at the base of the gantry. Along the centerline of the gantry, at ground level, is a strip of reinforced concrete 400 feet long, 30 feet wide, and 0.67 foot thick.

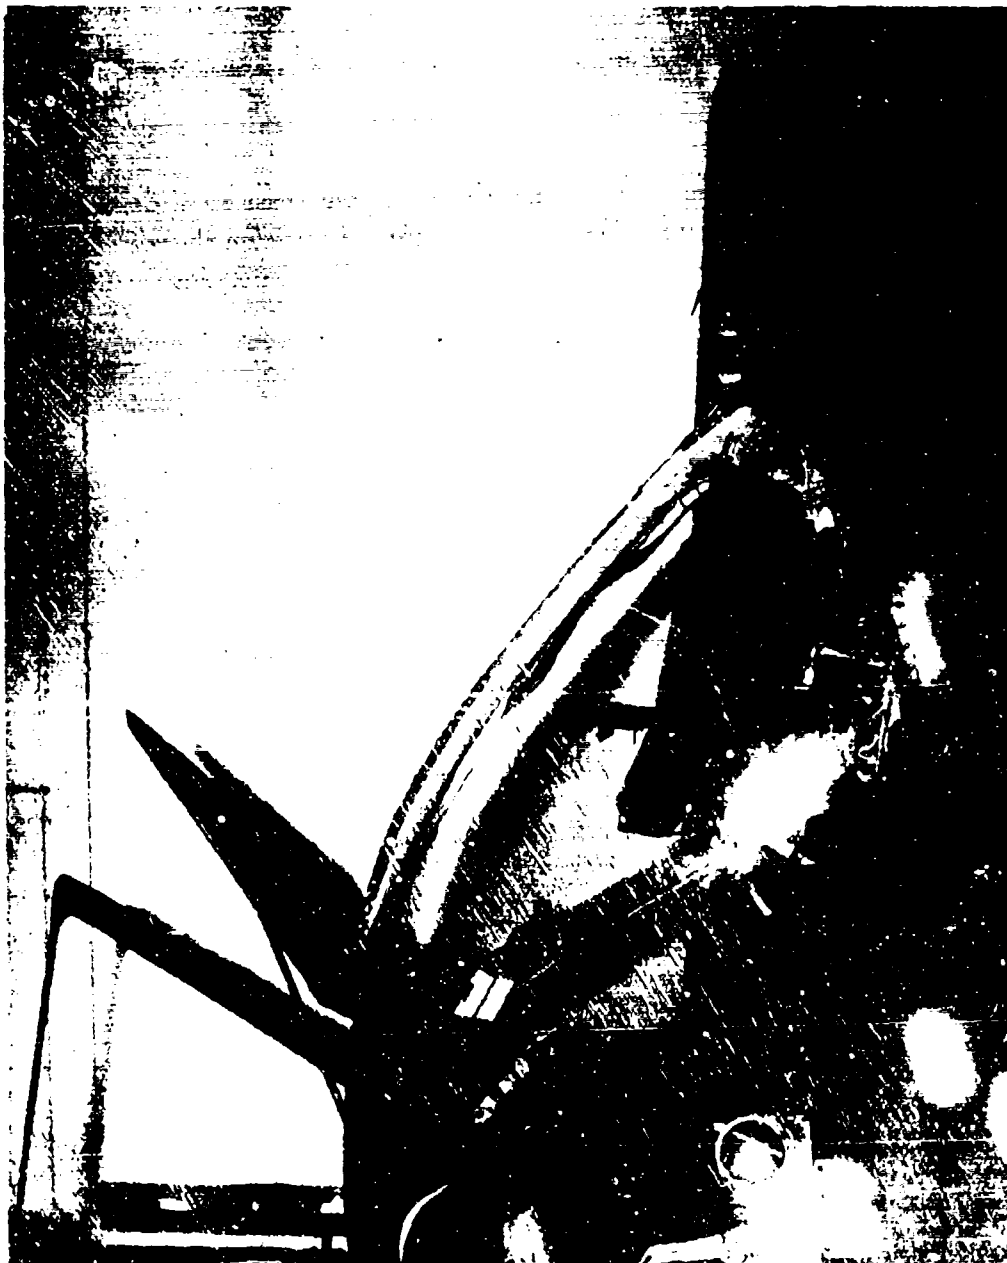
Figure 3. WSPS upper cutter.

The Canadian WSPS is shown installed on the test aircraft in Figures 3, 4, and 5. This is a cutter/deflector system with an upper cutter to protect the main rotor controls; a lower cutter to protect the skid gear; and a windscreen centerpost deflector with a serrated cutting edge insert to deflect wires to the upper cutter, to cut copper and aluminum wires, and to reinforce the centerpost structure. The WSPS is a passive system, having no moving parts. Upon wire impact, the helicopter momentum deflects the wire or cable into the upper or lower wedge-shaped cutter, where it is notched to the extent required for easy breakage in tension. The total OH-58A WSPS weight is 16.3 pounds, including all supporting structure and the mounting plates. Installation of the WSPS required approximately 40 man-hours.

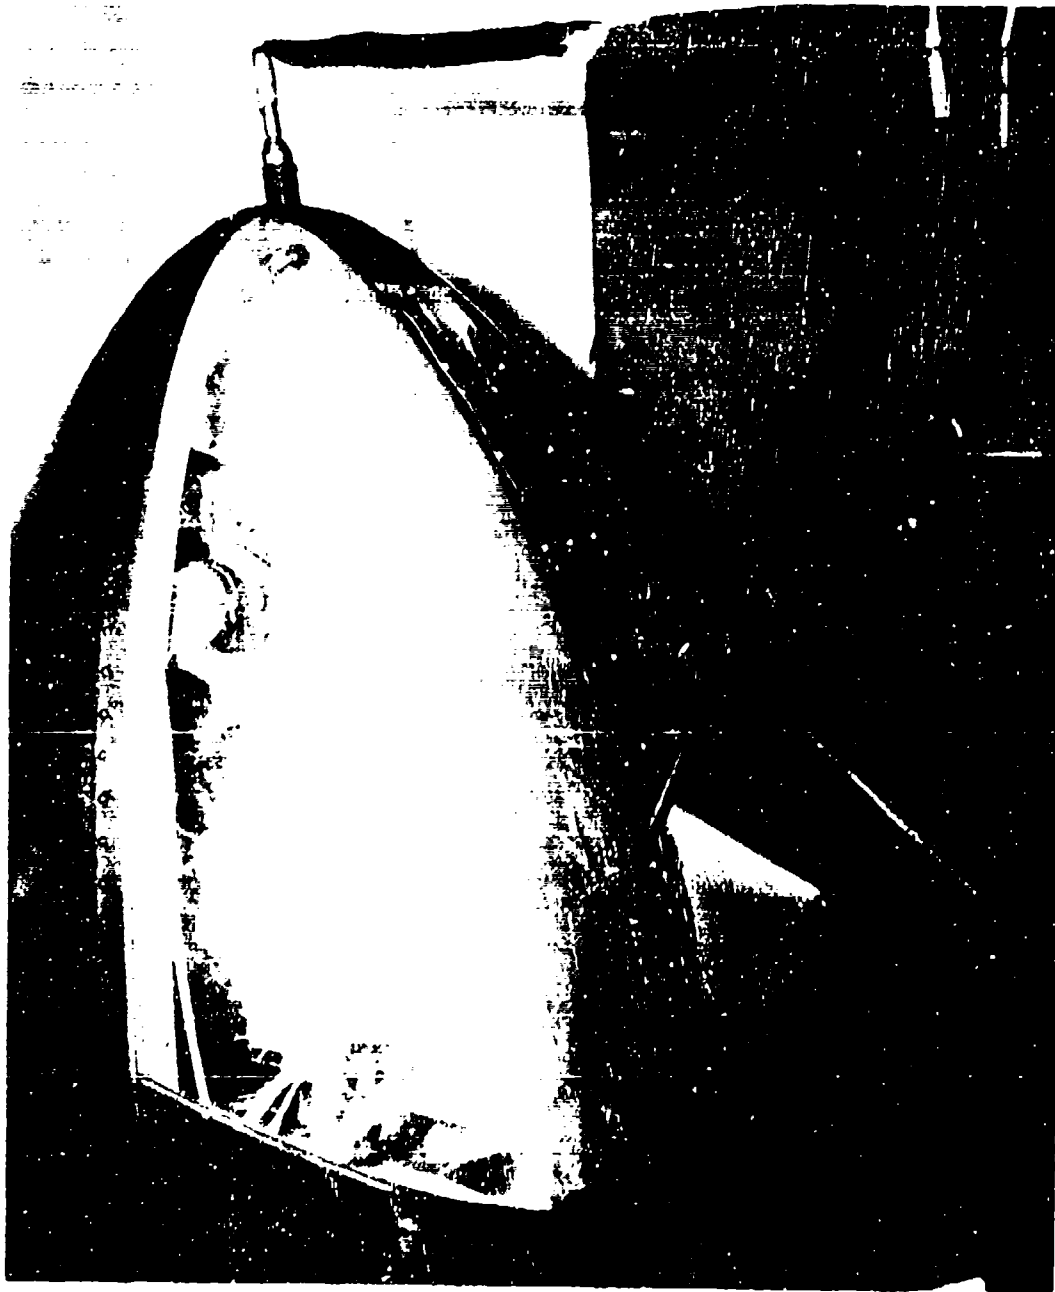
Figure 4. WSPS lower cutter.

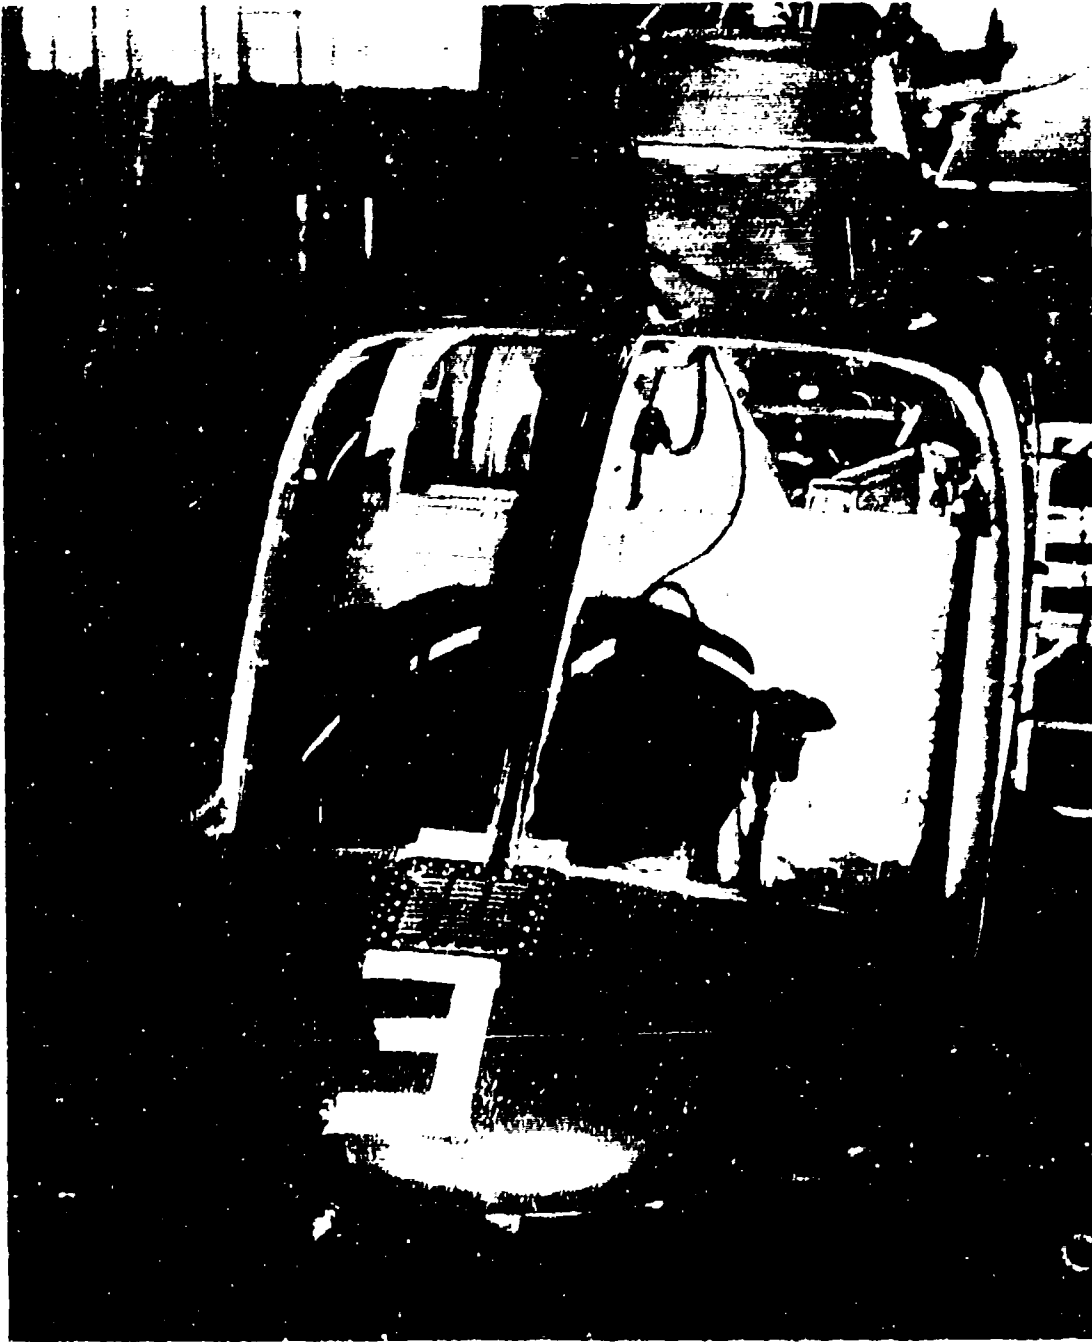
Figure 5. WSPS windshield centerpost deflector.

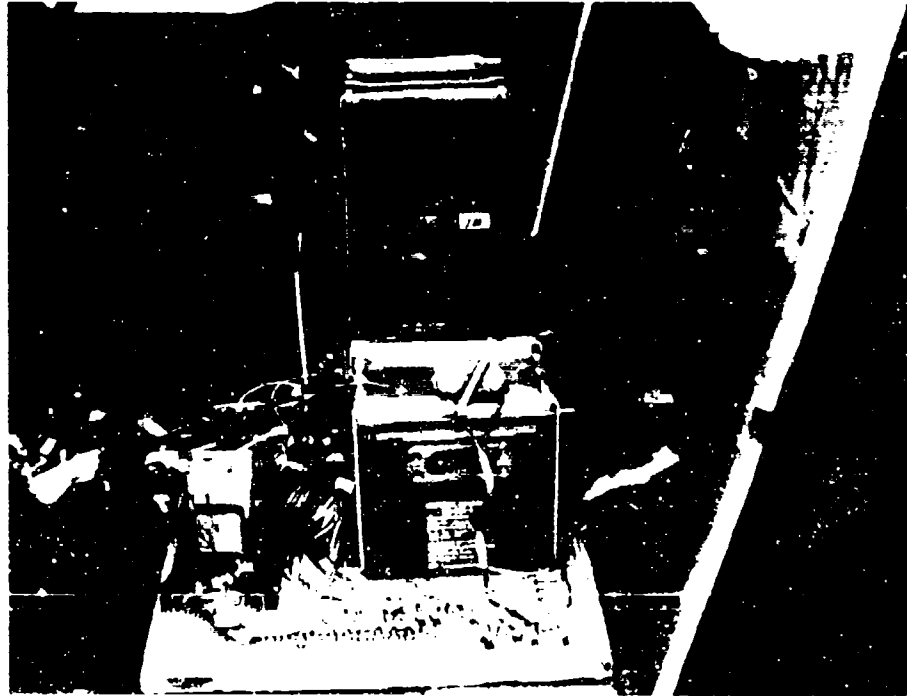
Figure 11. Test instrumentation and battery installation.

Nine instruments were used to record data during the tests. These included gyros to measure pitch, roll, and yaw attitude and pitch rate; accelerometers to determine the longitudinal, vertical, and lateral loads a pilot would experience during wire impact; and load cells to measure the wire tension increase throughout the deflecting/cutting sequence. The instrumentation and battery package as installed in the rear seat of the test aircraft is shown in Figure 11.

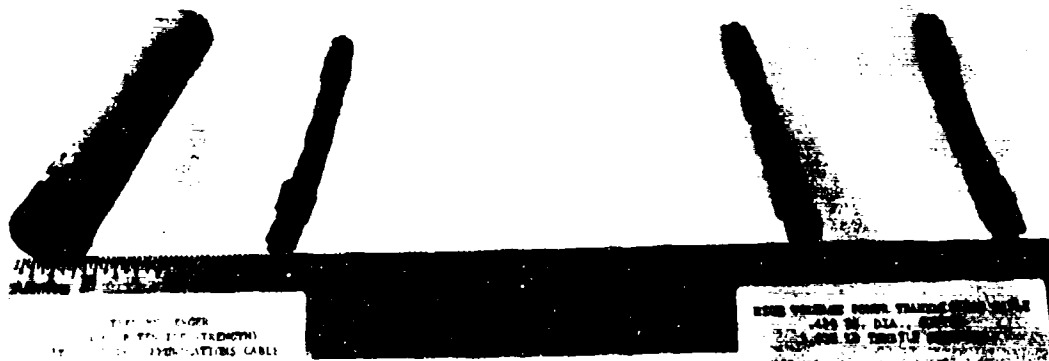
Figure 28. Description of multiple cables for Test 7.

This test used two 0.419-inch-diameter power transmission cables and one 10M cable supporting a 50-pair commo cable as the objective wires. Since multiple wires are involved in many helicopter wire strike accidents, this test was of great value. The objective wires are depicted in Figures 28 and 29. Arrangement and spacing of the cables were in accordance with standard installation procedures when there is a mix of power transmission and communication lines supported by the same poles.

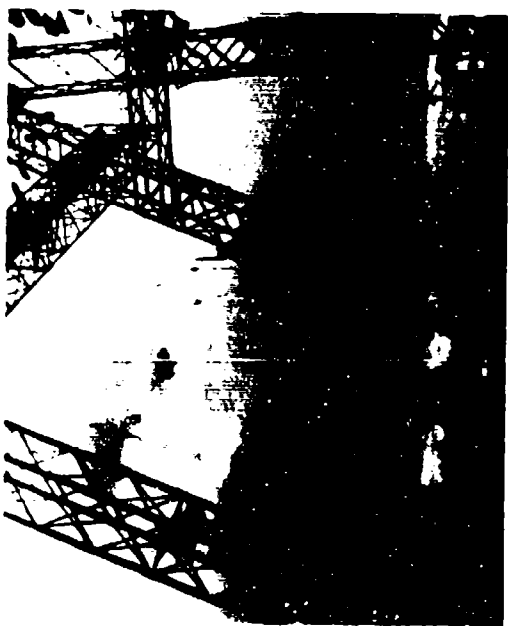
Figure 30. Multiple wire test sequence.

Weather conditions for this test were poor with rain resulting in the inability to use most of the ground movie cameras and both of the 70mm still sequence cameras. However, this was the last day of facility availability and the test was accomplished during a short break in the rain shower activity. The test was a complete success, as depicted by the photo series in Figure 30. The two copper high-voltage power transmission cables impacted the windshield centerpost and deflected upward to the cutter. One of these cables was cut by the sawtooth cutter inserted in the deflector. The other was weakened by this cutting edge and was finally severed in the upper cutter. The 10M steel cable with the supported 50-pair communication cables was deflected into the lower cutter and easily severed. It should be noted that after two cuts (Tests 5 and 7) the lower cutter showed no signs of scoring and only had some paint removed from it. With a multiple wire strike, the deceleration forces were expected to be greater than that of a single wire strike. This was the case, as shown in Figures 31 and 32, which depict the longitudinal and lateral forces respectively. For a longitudinal force peak of less than 2 g or an average of less than 1 g, over a pulse period of less than 50 milliseconds a pilot would

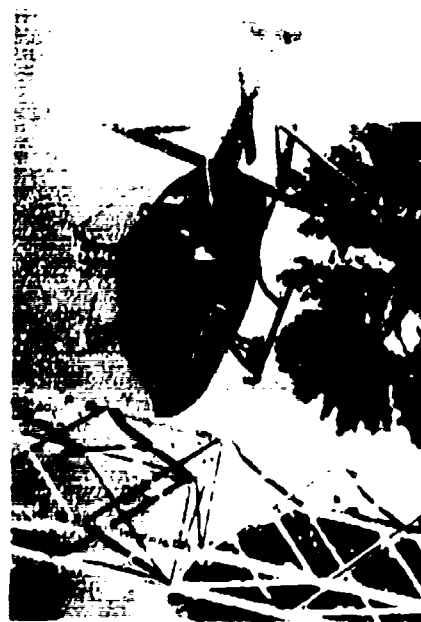
Figure 34. Wire impact sequence during test.

Figure 34 shows the wire impact sequence. As can be seen, the right side of the deflector was subjected to the entire impact load and bent inward, snagging the wire and preventing deflection. The right skid was broken and the wire became caught on the forward skid gear cross tube. The resulting forces were such that the left line pole supporting the cable was broken at ground level and thrown approximately 170 feet to a position forward and to the right of the aircraft (Figure 35). The right pole was left leaning with guy fixtures pulled from the ground. This can be seen in the background of Figure 36. The 10M messenger and 50 pair communications cable were not damaged. The skid gear deflector was thrown to the apron (see Figure 37).

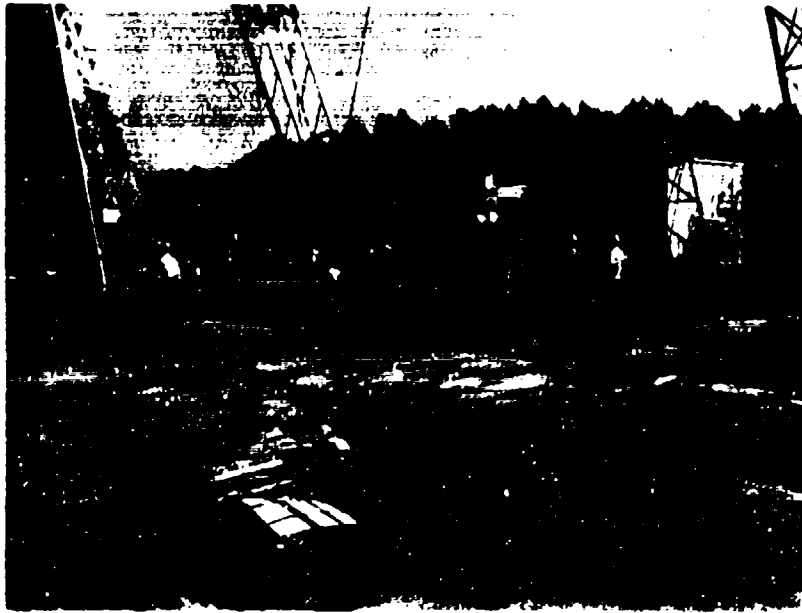
Figure 35. Left line pole after test.

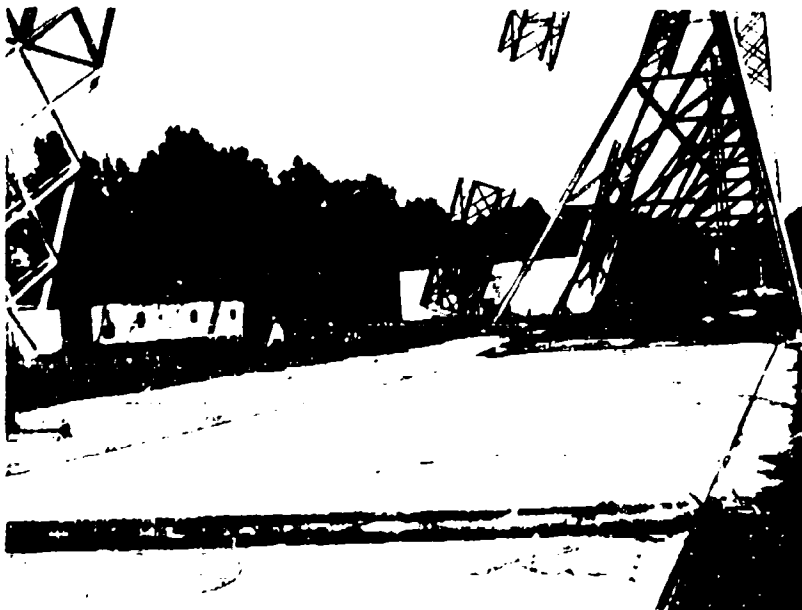
Figure 36. Right line pole after test.
